Re: Crandall Canyon Mines, C/015/032
Change to Drainage Control Plan, Water Aeration Treatment Area

CRANDALL CANYON #1 MINE and the SOUTH CRANDALL MINE

CHANGE TO THE DRAINAGE CONTROL PLAN
FOR THE

MINE DISCHARGE WATER
AERATION TREATMENT FACILITY

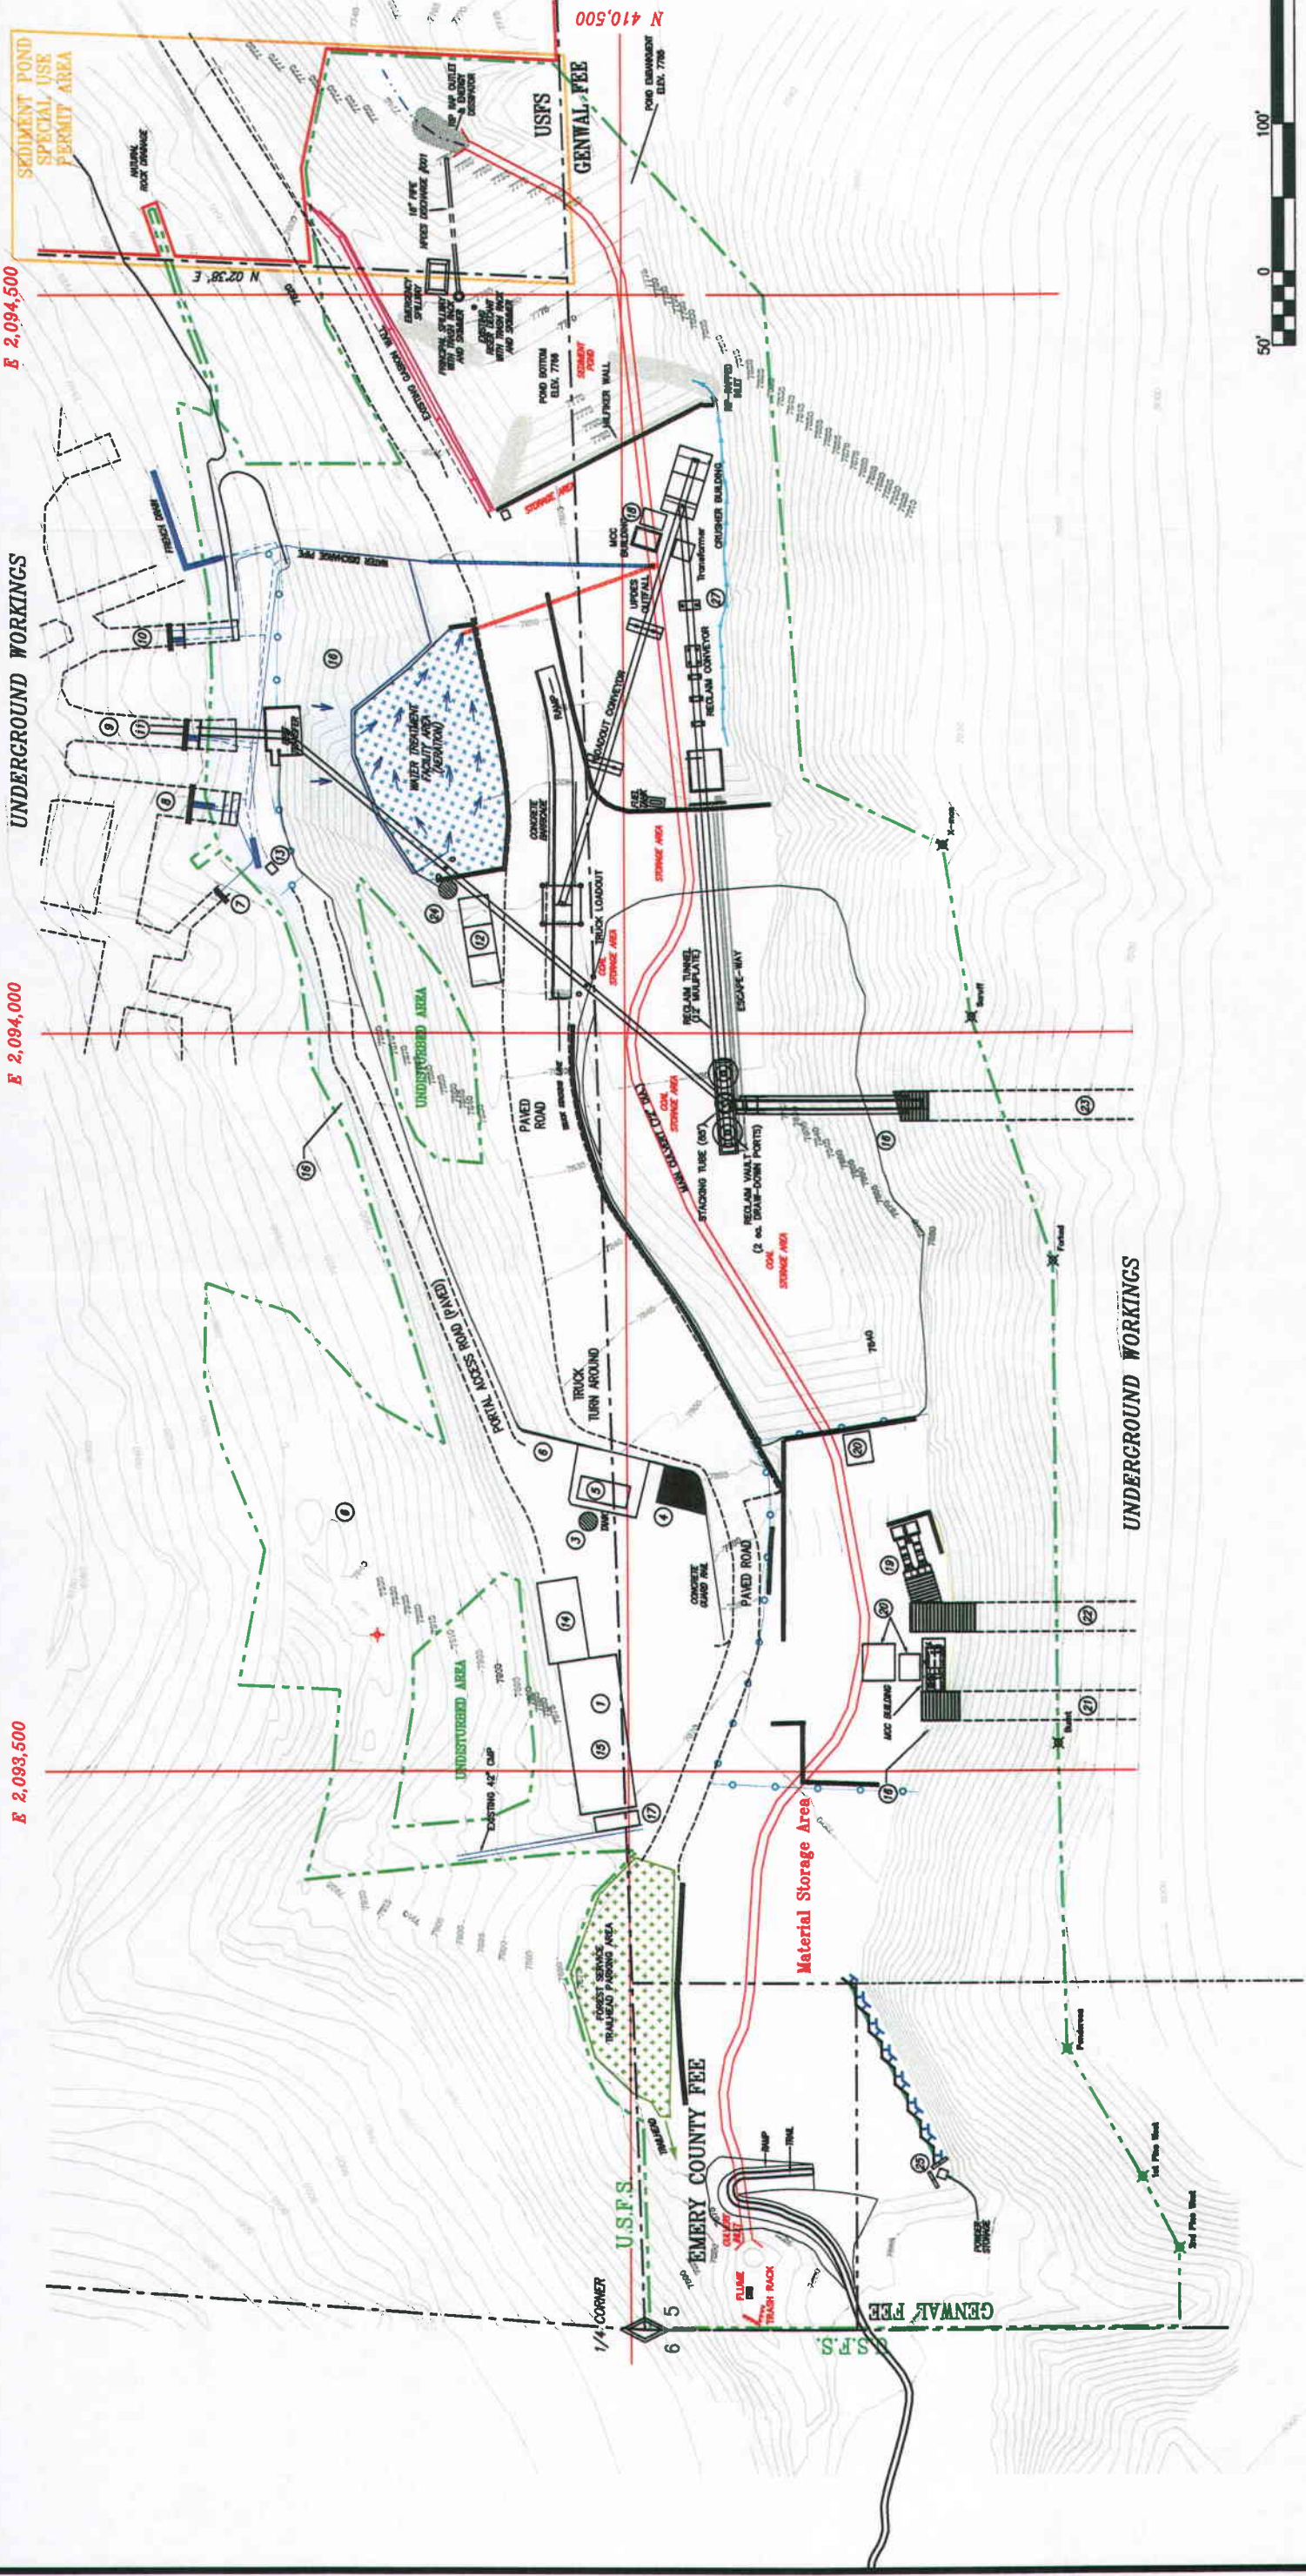
CRANDALL CANYON MINE SURFACE FACILITIES			
REV: 16	ACUP: 5-3	BY: PJJ	PLATE #: 5-3
DATE: 2-13-09			
SCALE: AS SHOWN

- FACILITY LEGEND:**
- 1. Shop
 - 2. Ventilation Fan
 - 3. Rockdust Silo
 - 4. Concrete Dumpster Pad
 - 5. Power Center
 - 6. Power Pole
 - 7. Offices & Bathhouse (u'grd)
 - 8. Intake Portal
 - 9. Belt Portal
 - 10. Fan Portal
 - 11. Mine Belt
 - 12. Oil Storage
 - 13. Visual Disconnect

- 14. New Warehouse and Office Building
- 15. 4500 Gallon Cullinary Water Tank
- 16. Shotcrete
- 17. Parts Shed
- 18. Portable Shed
- 19. Ventilation Fan
- 20. Material Storage Sheds
- 21. Intake Portal
- 22. Return Portal
- 23. Belt Portal
- 24. Mag Tank
- 25. Powder Storage
- 26. Cap Storage
- 27. Concrete Ditch

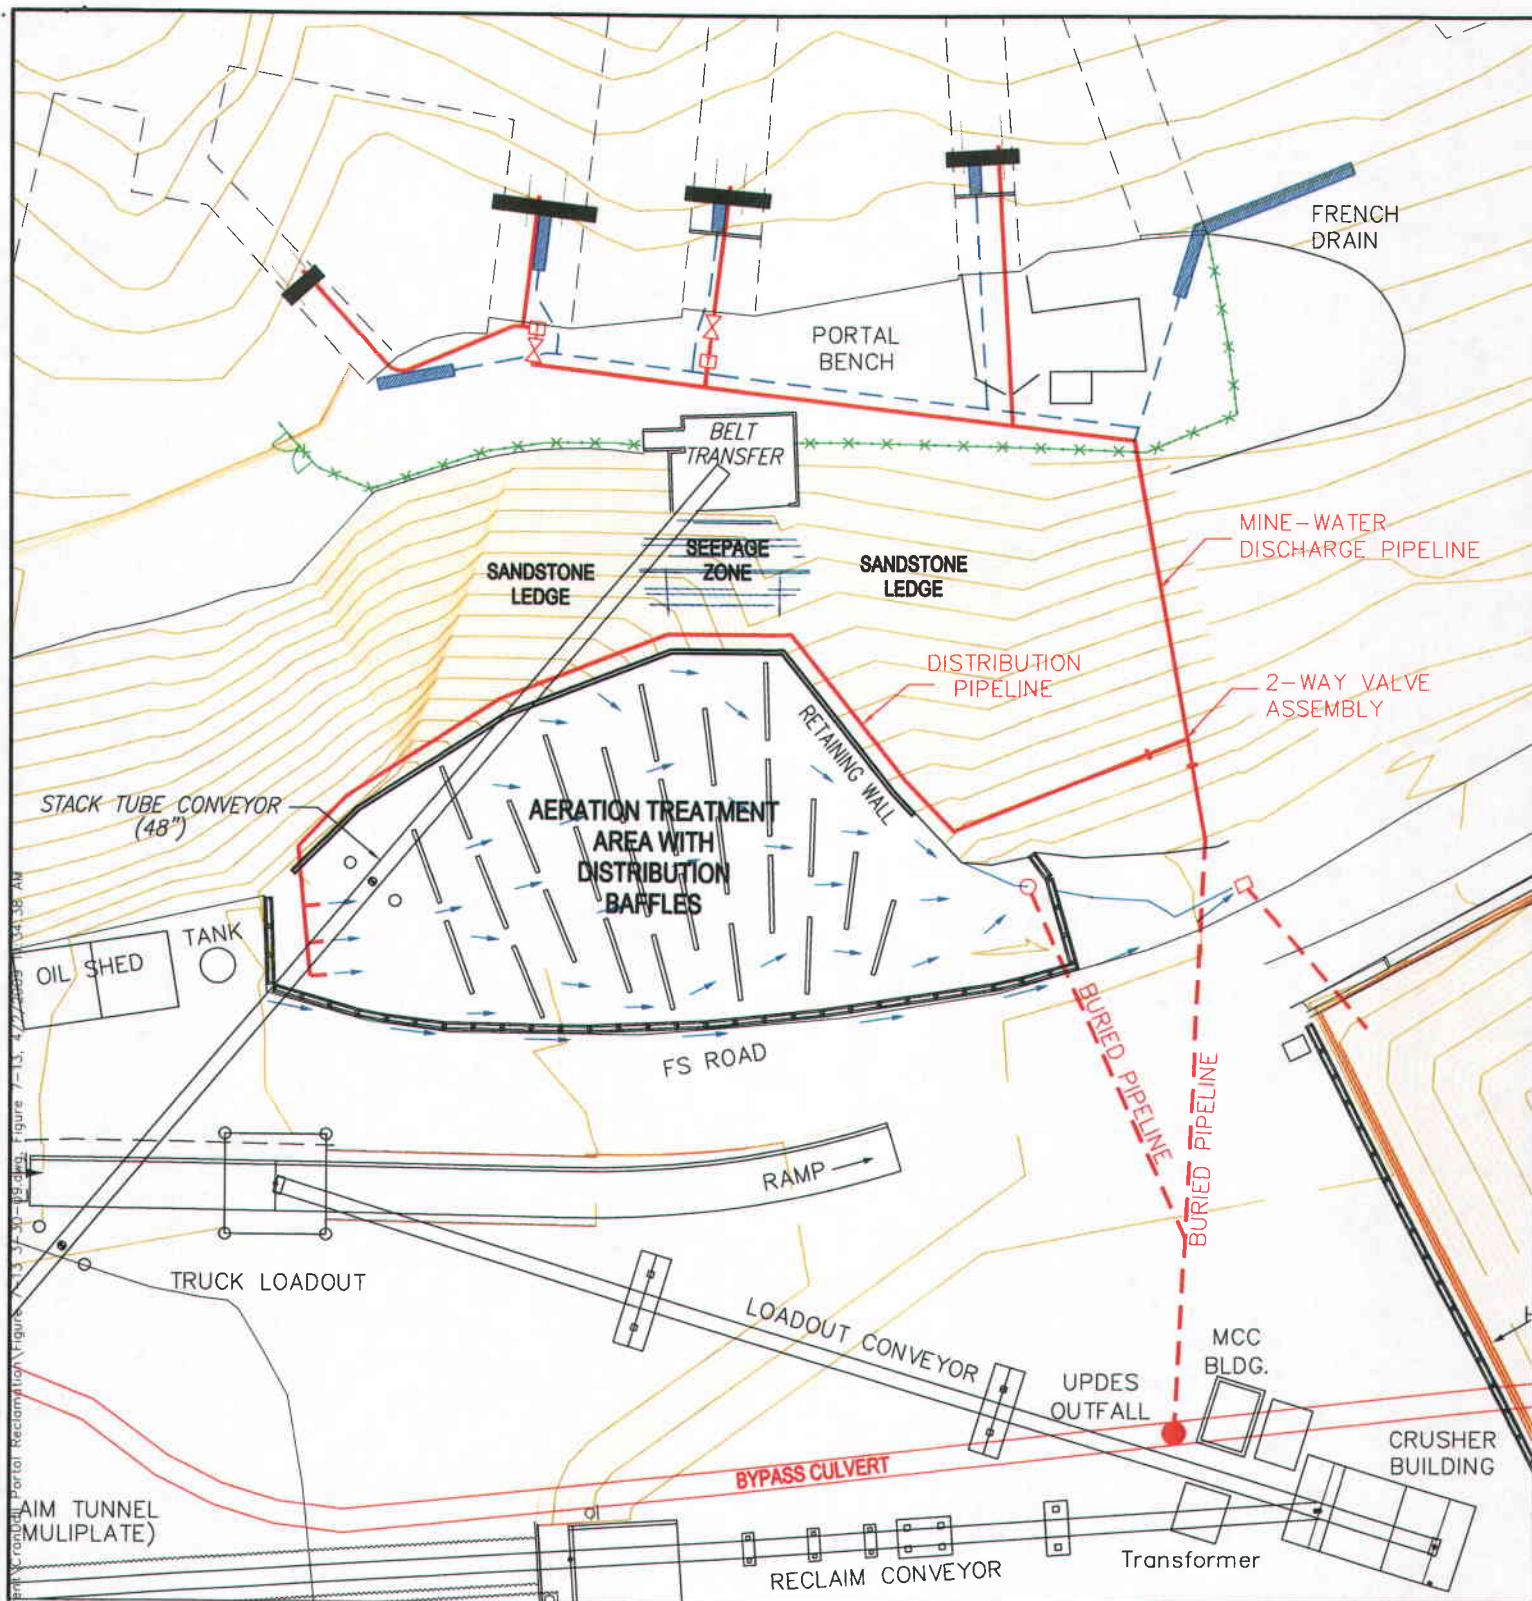
FIGURE FIGURE 7-13a

MINE-WATER DISCHARGE TREATMENT FACILITY

It should be noted that the "old loadout area" is located primarily within a large notch that was blasted out of the solid Star Point Sandstone when the facility was originally constructed in the early 1980's. The area will first be cleaned of all coal materials to reveal the under-lying granular borrow base. The area will then be leveled in a north-south direction (transverse to the water flow) and smooth-graded in the west-east direction (along the direction of flow). The area will then be surfaced with a water-proof treatment (i.e., concrete, asphalt, impervious liner, etc.) to make certain that the water flow across the treatment pad does not saturate the underlying fill material. Because the floor of the treatment pad will be at a lower elevation than the adjacent roadway, the aeration waterflow will be contained at all times within a lined treatment basin. This will ensure that the adjacent fill under the roadway stays dry and retains its full stability.

The existing mine-water discharge pipeline, which comes down the bank from the portals, will be equipped with a tee and valve assembly. From this tee a new distribution line will be installed to carry the discharge water to the upper (western) end of the treatment area. This distribution pipeline will be suspended either from off the existing concrete wall (left over from the old loadout facility) or suspended from rock anchors affixed to the solid ledgerrock. The distribution line will be valved at the tee so that water can be turned into the treatment area, or can be directed back into the existing discharge line. This ability to bypass the treatment facility will be advantageous at time when the facility needs to be taken off-line for construction, maintenance or adjustments.

A suitably constructed barricade would be constructed around the treatment facility along the outer edge of the treatment basin (between the treatment basin and the road) which will prevent any disturbed area drainage from entering the treatment facility area, and similarly will prevent any of the mine discharge water from spreading over the adjacent disturbed area and reporting to the sediment pond. See Plate 5-3 for the location of the facility. This treatment area is also designated as ASCA 12 in the Sedimentation and Drainage Control Plan found in Appendix 7-4 and Plate 7-5. See Figure 7-14 for a schematic representation of the aeration facility, as well and the mine-water discharge piping and French drain collection system at the portals.

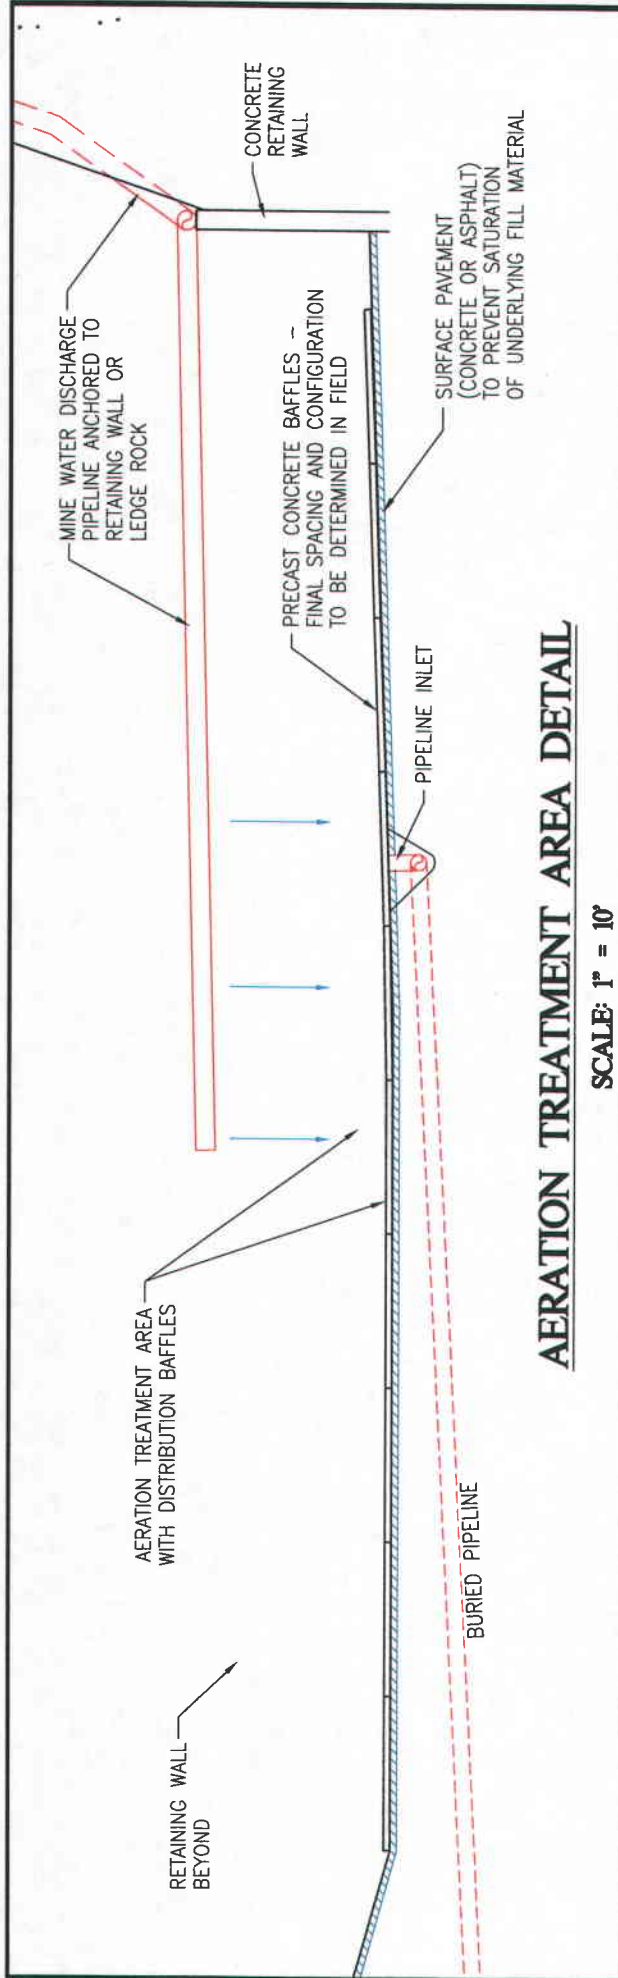
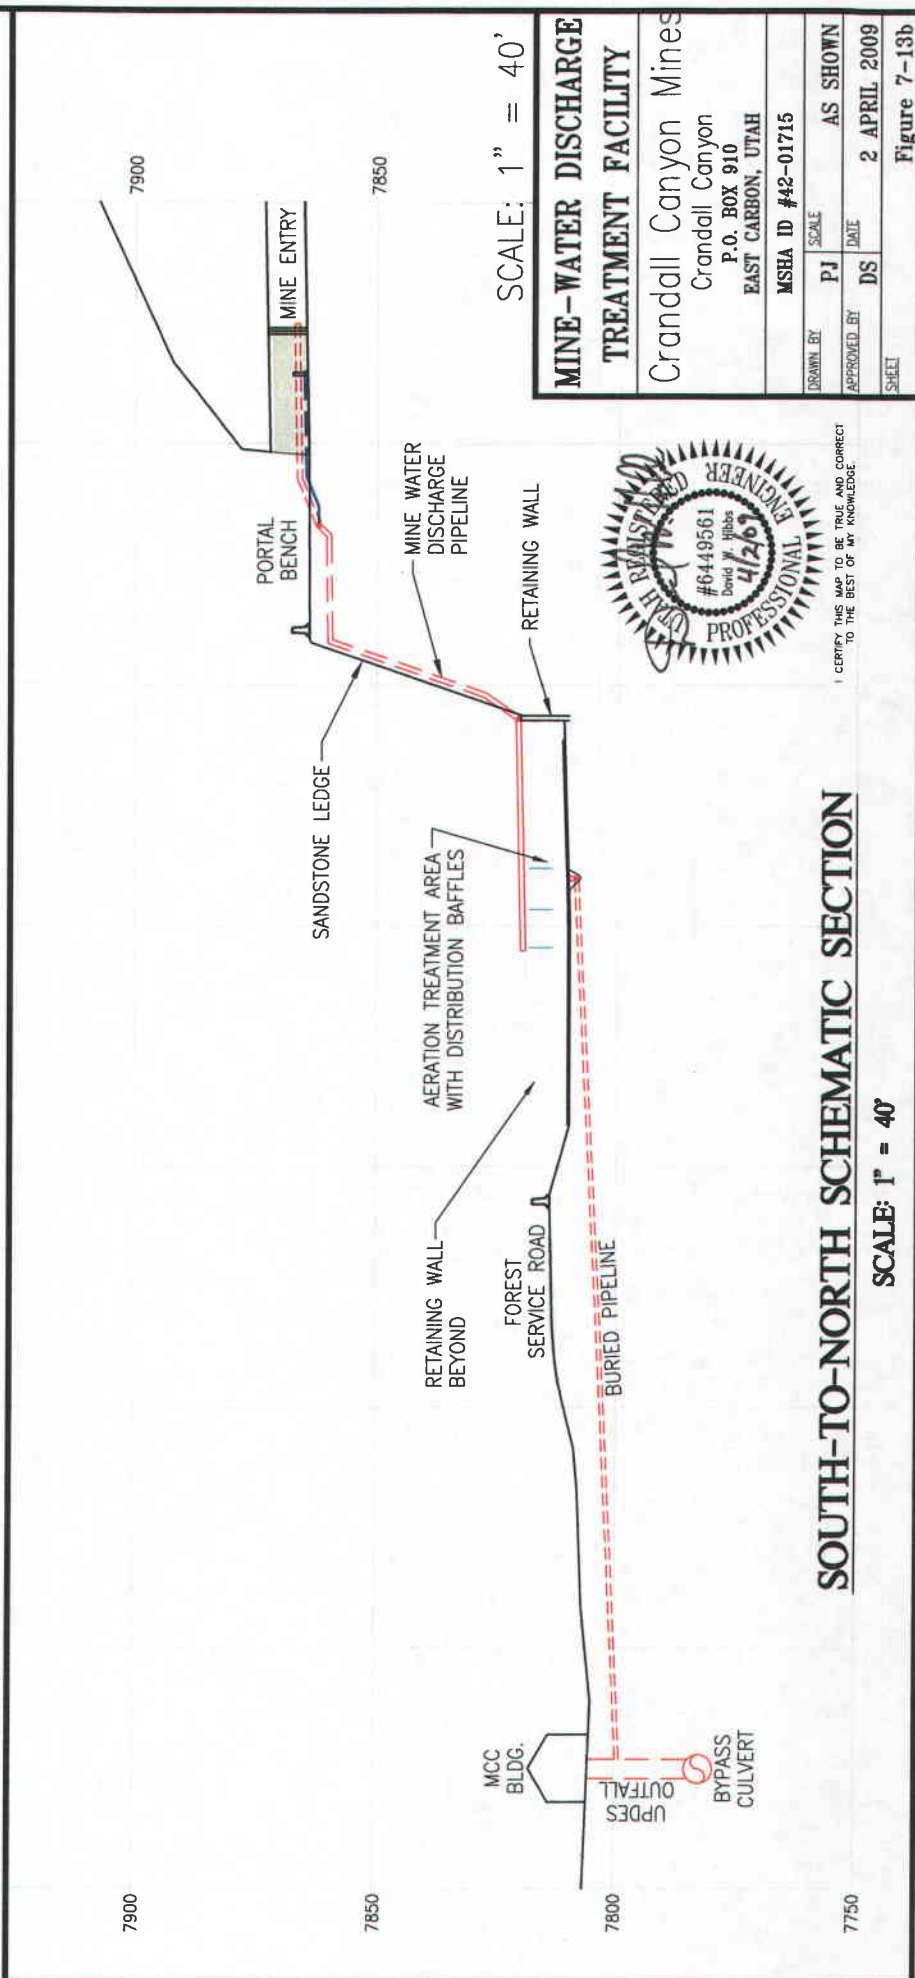
Figure 7-13b

AERATION TREATMENT AREA DETAIL

WEST-TO-EAST AERATION TREATMENT AREA SECTION

Between the curbs will be a 2"-3" layer of sorted gravel which will help trap the iron precipitate particles to prevent them from continuing on downstream to the UPDES outfall. The gravel material will also provide a better surface area for the iron sulfides to adhere. This gravel may consist of a crushed limestone to help chemically in the iron removal process. It will also be possible to add a chemical flocculant and/or coagulant to the water at the upstream end to aid in the iron removal process. This gravel/crushed rock layer will be removed and replaced as necessary as it becomes overloaded with iron precipitates.

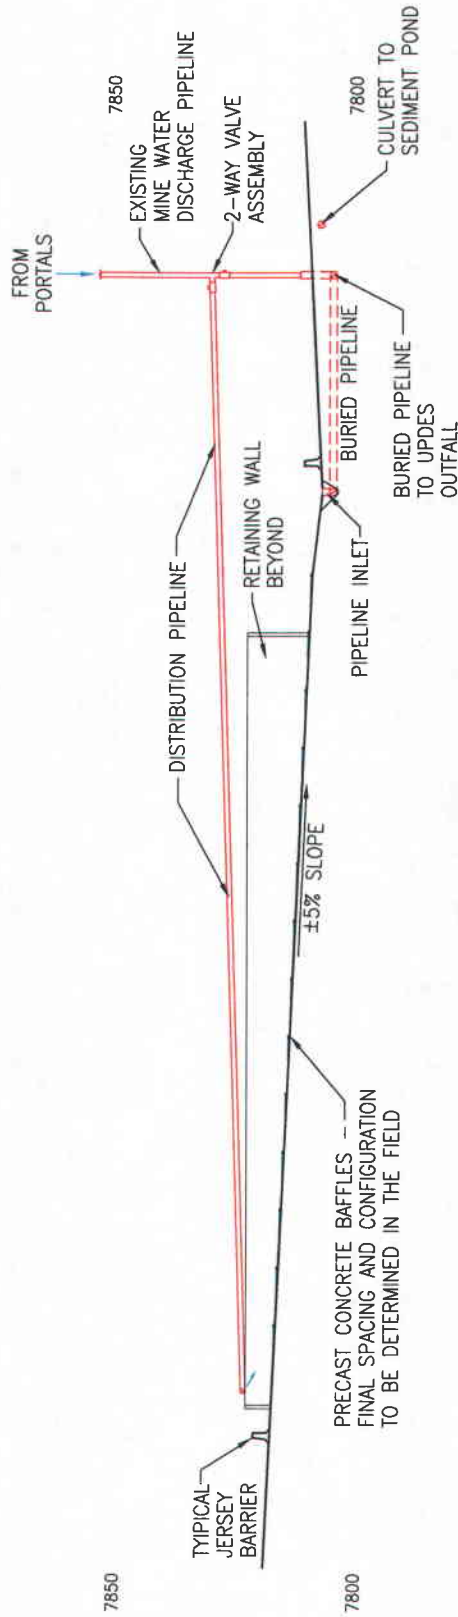
SCALE: 1" = 40'

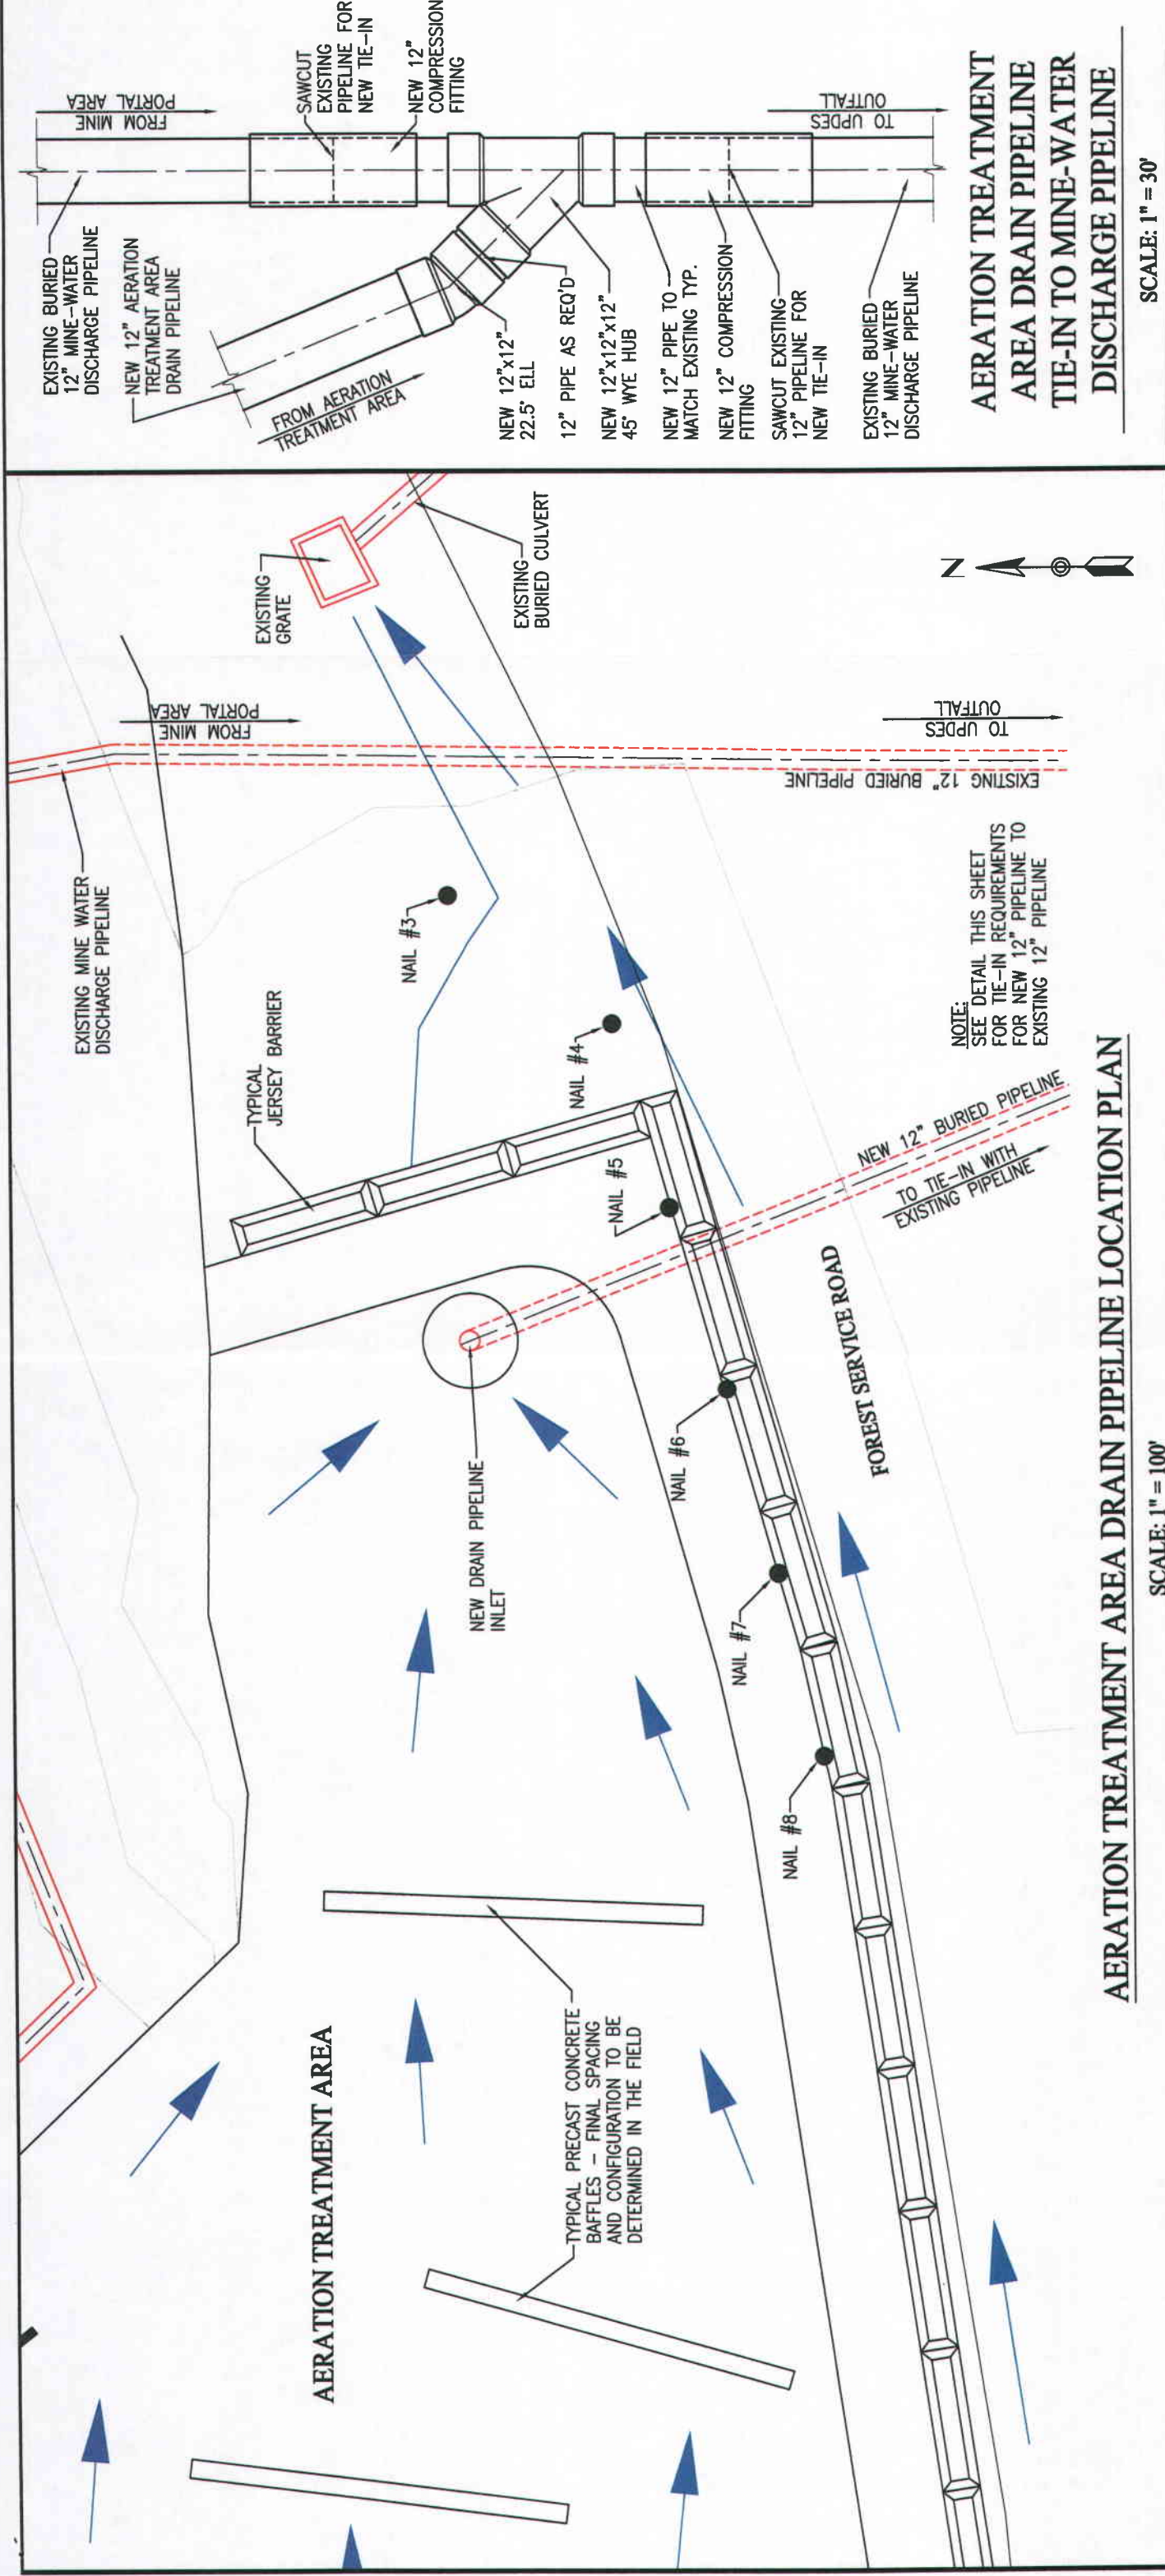
AERATION TREATMENT AREA DRAIN PIPELINE LOCATION PLAN

SCALE: 1" = 100'

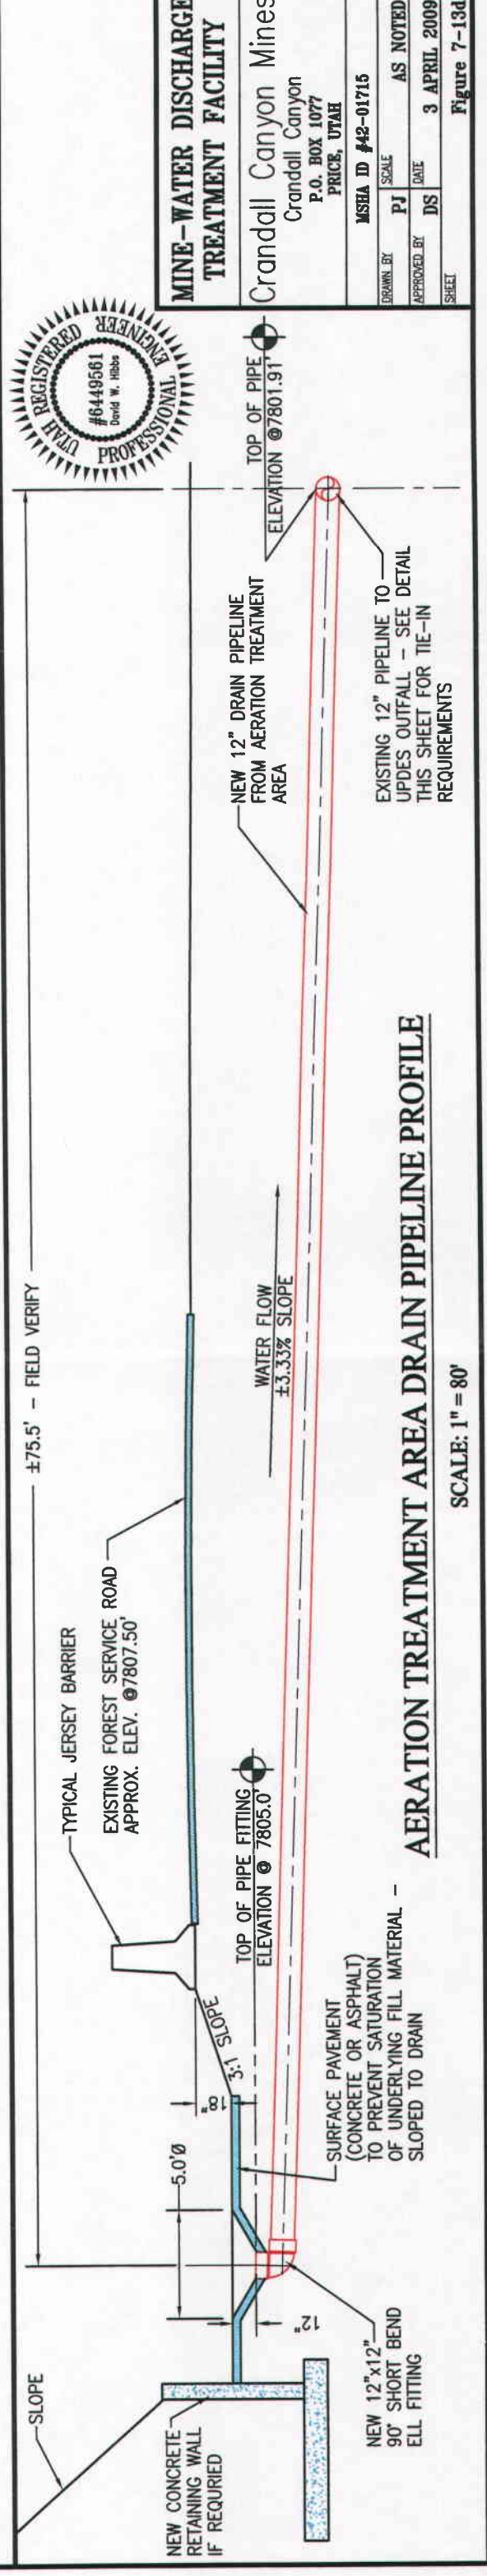
AERATION TREATMENT AREA DRAIN PIPELINE PROFILE

SCALE: 1" = 80'
